**SUBJECT: START 3, EPA Region 8, Contract No. EP-W-05-050, TDD No. 1008-13
Trip Report, Upper Animas Mining District, Silverton, San Juan County, Colorado**

TRIP REPORT
Upper Animas Mining District
Silverton, San Juan County, Colorado

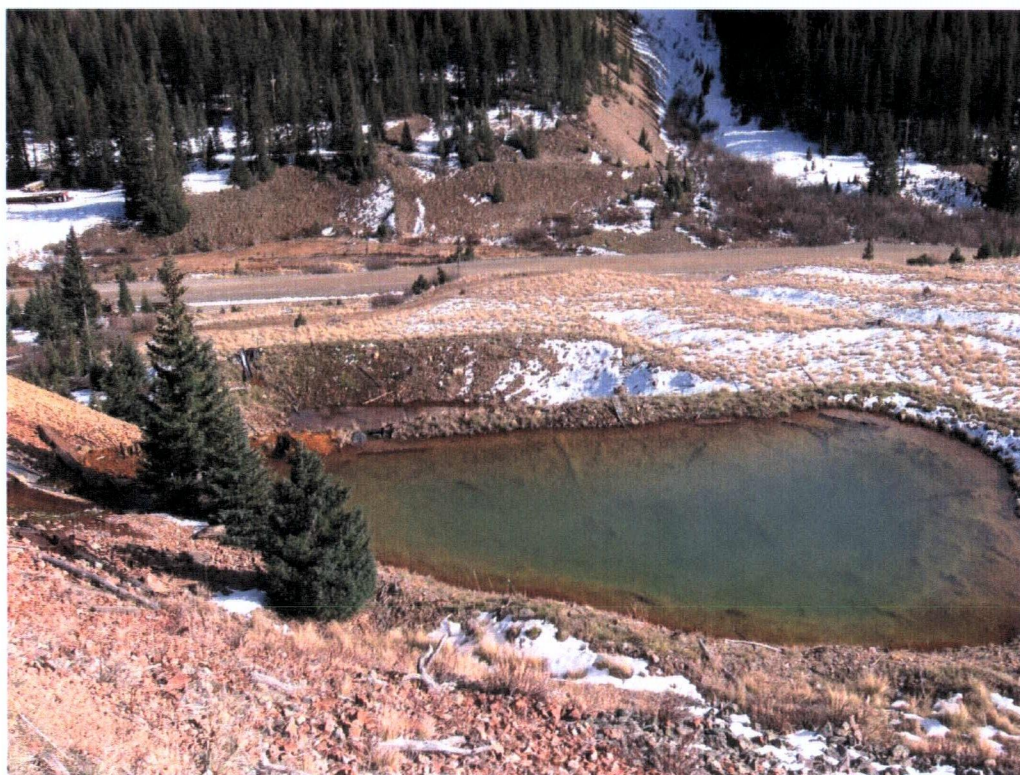
Photo 71
Mogul Mine waste piles.
